## CASE REPORT

# Head slippage following displacement of a Mayfield head clamp leading to a unique complication of laryngeal edema in an intubated patient: case report

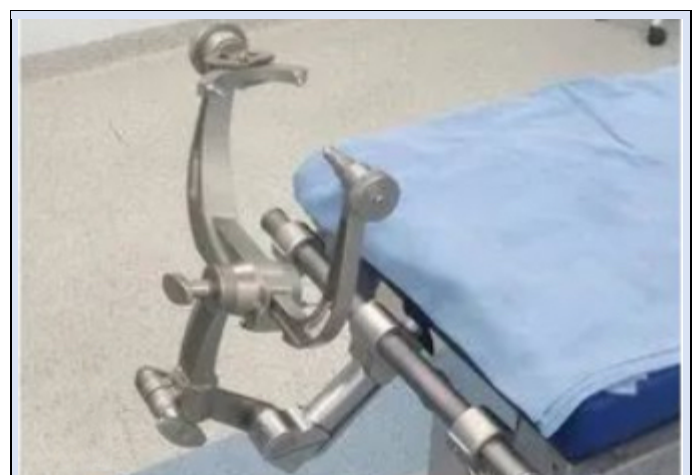
The Mayfield head clamp (MHC) (MAYFIELD™, Ohwa Tsusho Co., Ltd., Tokyo, Japan) and (Ohio Medical Instrument Co., Cincinnati, Ohio) (**Figure 1**) is the most frequently used head clamp system in the field of neurosurgery. In many cases, surgery is performed with complete reliance on the safety of the MHC<sup>1</sup>.

**Figure 1.** Mayfield head clamp apparatus.

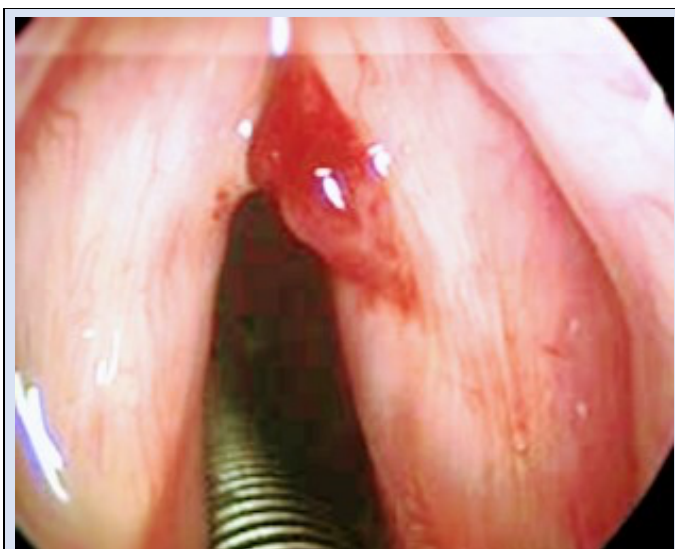
During reintubation, marked laryngeal edema was noted with a slight contusion over vocal cords (**Figure 2**).

**Figure 2.** Laryngeal edema with vocal cord injury..

To decrease swelling, systemic corticosteroid therapy was started along with nebulization. The chest surgery team was consulted. Chest and lung imaging was performed on an emergency basis. No tracheobronchial injury was found. The patient was weaned off the ETT over the course of the next 3 days with subsequent improvement in subcutaneous emphysema. The author experienced an extremely rare case of MHC slippage during removal and emphasizes the importance of properly managing and maintaining the instruments in order to prevent fatal injury.

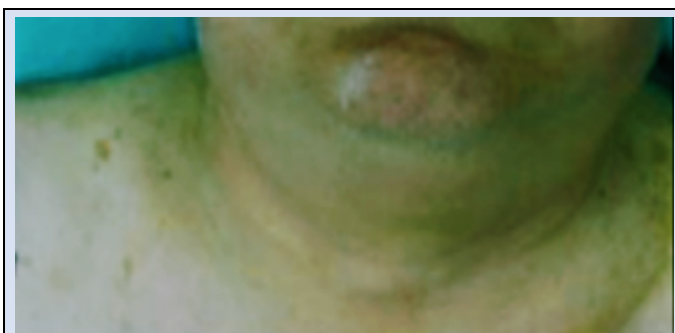
The patient was sedated, and 12 hours following reintubation, developed marked submandibular and supraclavicular emphysema more prominent on the right (**Figure 3**).

**Figure 3.** Submandibular and supraclavicular emphysema

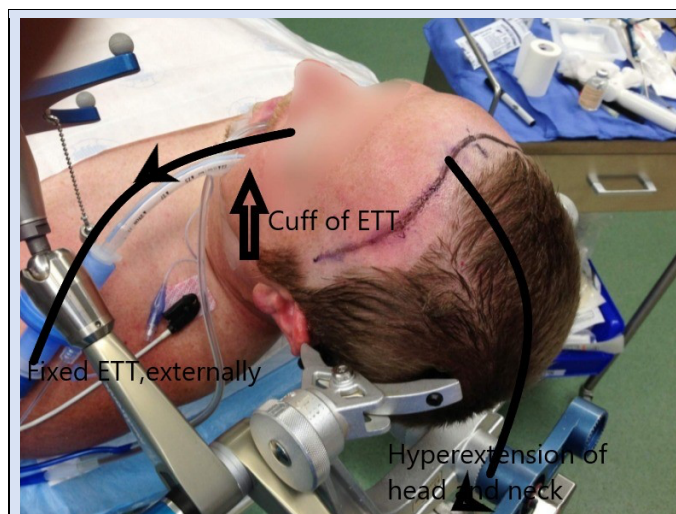
**Figure 4.** Possible mechanism of injury. ETT - endotracheal tube.

When the clamp was removed, a downward force was applied, leading to a loss of neck flexion with sudden loss of control due to loosening of lower arm screw. The cervical spine jerked despite head stabilization, leading to an upward displacement of the ETT. The underlying mechanism was probably fatigue related displacement of the screw after slippage.

The first step in preventing fatal injury is to apply and remove the instrument in the correct position with protection from impact and physical damage. Screws should be regularly checked to detect fatigue failure of the MHC. Also, all cleaning and sterilization procedures should be performed in accordance with the operating instructions provided by the manufacturer.

The surgeon should examine the apparatus thoroughly before each use. Finally, instruments should be subjected to regularly scheduled maintenance by the manufacturer through a separate contract when purchasing the MHC. However, most buyers ignore this aspect in an effort to reduce costs.
